Moss Building Water Infiltration

Ellington Agricultural Center

Programming Verification Report

August 26, 2018

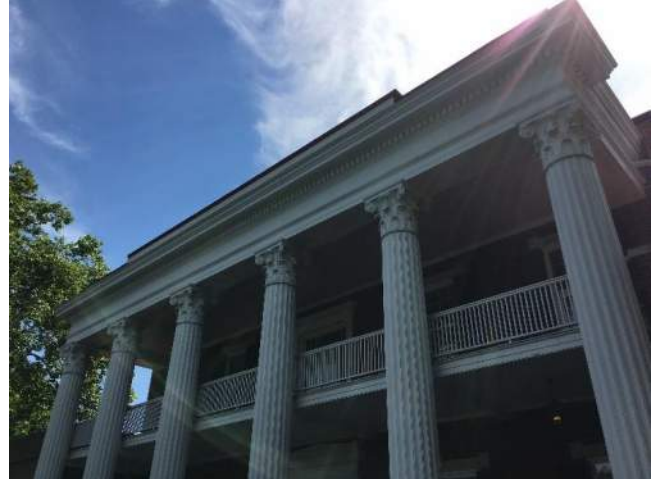
Photo 1

- 1) The Moss Building is located at the Ellington Agricultural Center in Nashville, Tennessee. The 2 story building was reportedly constructed in 1927 and has been renovated over the years to house the offices for the State of Tennessee's Department of Agriculture Commissioner, Budget, Human Resources, and Public Affairs representatives. The structural frame of the building consists of conventional "stick-built" post and beam wooden members. The roof system includes wood plank decking, 2"x6" timber roof trusses, covered with metal panels and small portions of EPDM membrane. The vertical walls include post and beam construction of multi-wythe brick masonry. The interior finishes consist of plaster and lathe at ceilings and walls. There are pre-cast concrete lintels and sills at the windows. There are four square brick chimney structures located at the north and south sides of the building near the high ridge point of the standing seam metal roof. The chimneys extend above the upper roof level and each are covered with decorative copper caps. There are second story covered porches on the front western side and back eastern side of the building with six large columns on each side with decorative architectural capital and leave pattern volutes above the neck of the column. *See photos 1-14 and 250-251.*

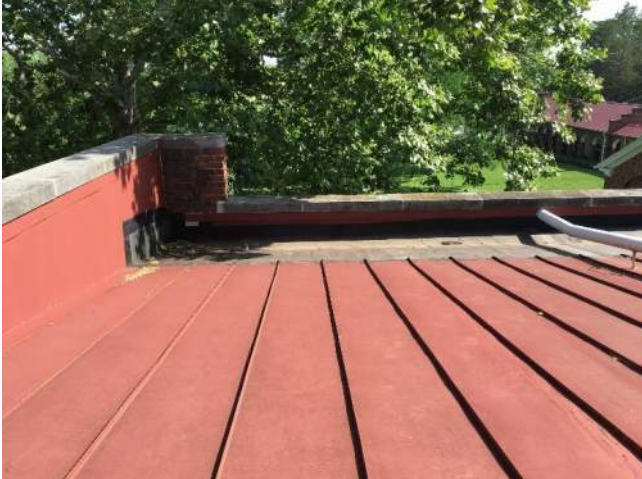
Photo 66

- g) Storage Closet: Another leak has occurred at the northeastern corner of the building in the ceiling of the storage closet. This leak is immediately below the location of the parapet wall at the scupper. Here the scupper is located in the corner on the horizontal field area of the roof immediately in front of the base flashing. See *photo 66 and 181*.

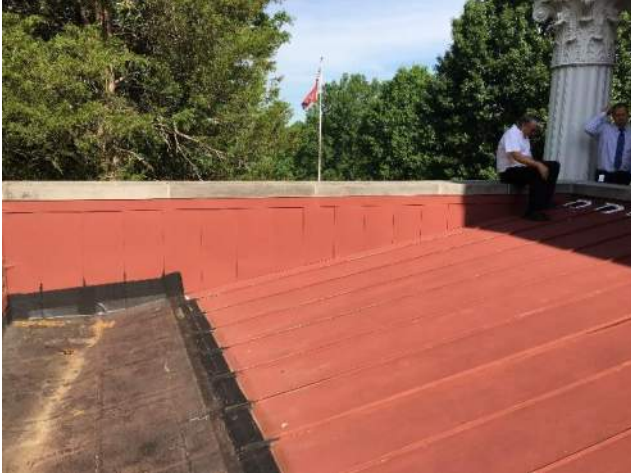
Photo 72

- b) Although the leaders from the upper to lower sections are large enough to handle the isolated flow of each scupper, the stark white appearance of the piping does not match the overall aesthetic of the other roof components which does not meet the goals of the Tennessee Historical Commission of maintaining an appearance typical of the original construction. See *photos 72 and 94*.

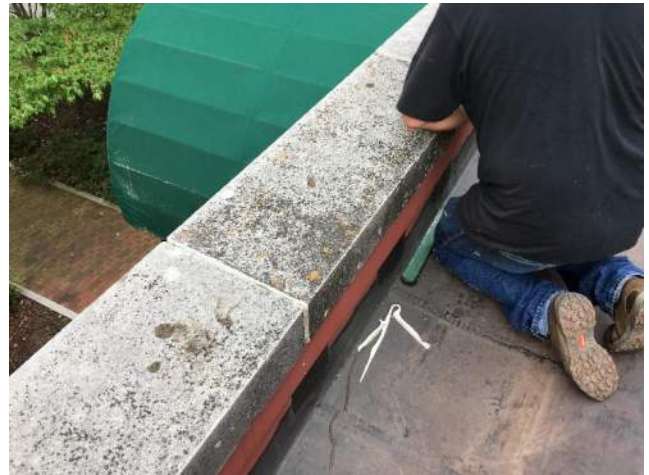
Photo 207

cap, there is more than enough room for water to enter above the metal and down into the wall space. See *photos 207-214*.
